Manhole Inspection Summary

Manhole # S55GG_003MH

Insp Date: **2/16/10 2:46 PM**

Location Address: **3800 Biddle St.**

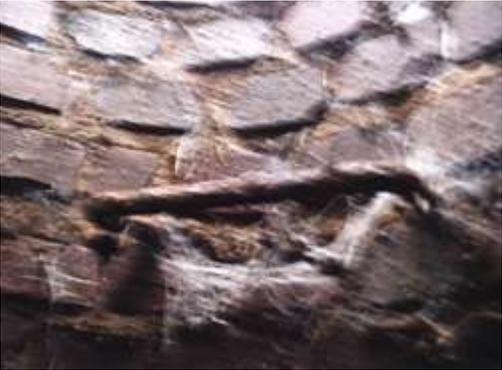
Defect 1

Steps Count: **4** Missing: **0** **Corroded**

steps

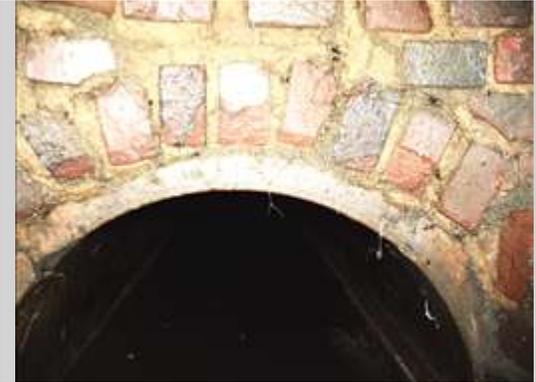
12 O'Clock Outflow

24 in. Circular Gravity Sewer
Pipe Out @ 12 O'Clock

Pipe Height: **27.6** (in.) Rod and Bar (Angled)
Pipe Material: **Clay** Pipe Lined
Invert Depth: **11.50** (ft.) Flow Characteristics: **Slow**
Deposits: None Mud Sludge Debris Grease
Silt Depth: (in.) Deposits Extent:
Infiltration: **None** Pipe Seal Cond: **Sound**

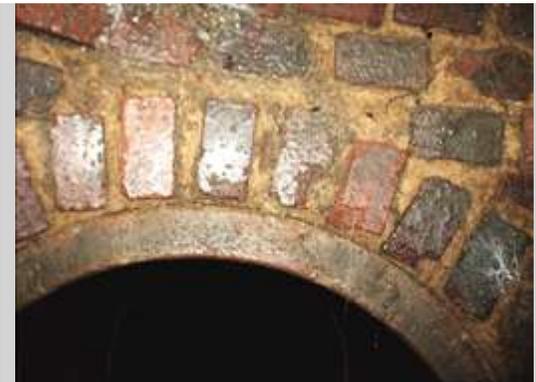
6 O'Clock Inflow

24 in. Circular Gravity Sewer
Pipe In @ 6 O'Clock

Pipe Height: **27.6** (in.) Rod and Bar (Angled)
Pipe Material: **Clay** Pipe Lined
Invert Depth: **11.42** (ft.) Flow Characteristics: **Slow**
Deposits: None Mud Sludge Debris Grease
Silt Depth: (in.) Deposits Extent:
Infiltration: **None** Pipe Seal Cond: **Sound**
